# Interference measurement and localization at major events

## 7<sup>th</sup> World Meeting of Families with Pope Benedict XVI as an example of how the IDA-3106 can be used

This Application Note describes typical interference problems, their analysis and their localization, using this major event as an example.

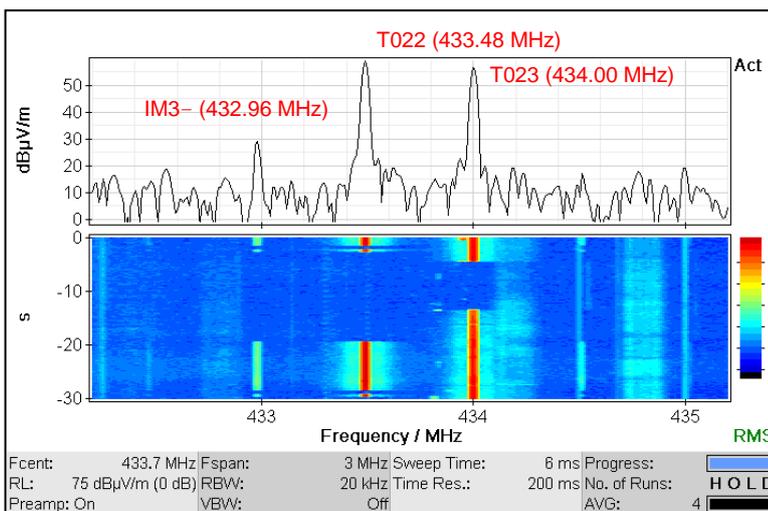
**Figure 5: Spectrum and spectrogram of the 433 MHz band showing the two strong emitters in channels T022 and T023 along with the intermodulation product IM3-**

The ARI (Associazione Radioamatori Italiani) uses 432,95 MHz for communications. Time and again, this channel is impaired by a neighboring channel, which is not easy to identify. With IDA-3106 MAX trace we found the intermittent interferer in spectrum at 432.96 MHz (figure 5).

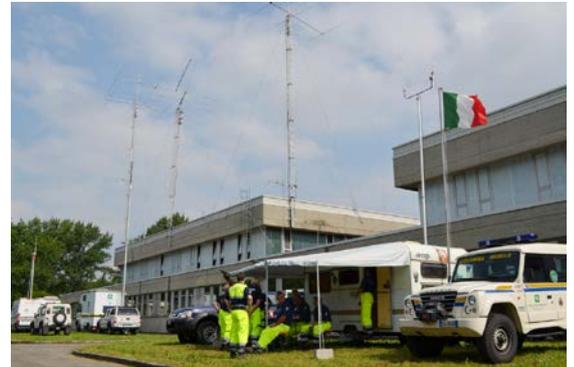
**Figure 3: The close proximity of different radio services means that intermodulation can be expected.**

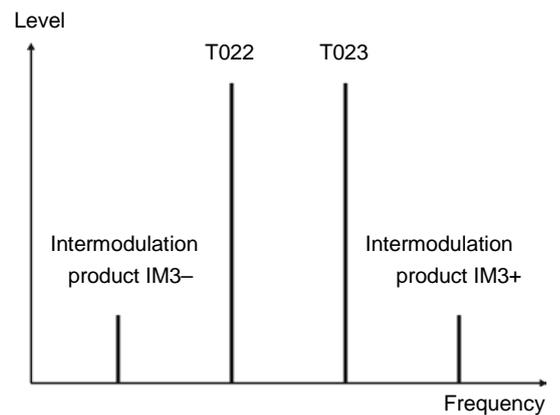
**Figure 4: The 3<sup>rd</sup> order intermodulation products occur principally at the frequencies**

$$f_{T023} + (f_{T023} - f_{T022})$$

$$f_{T022} - (f_{T023} - f_{T022})$$

Analysis of the spectrum and an understanding of how 3<sup>rd</sup> order intermodulation occurs leads to two radio services that both only transmit for a maximum of 20 seconds at a time in accordance with the constraints imposed by radio discipline. The spectrogram clearly shows the time correlation between the interferer (432.96 MHz) and the two services on channels T022 (433.48 MHz) and T023 (434.00 MHz). Since the interference only occurs briefly at the exact time when both T022 and T023 are transmitting simultaneously, indirect localization of the interference source from the frequencies causing the interference is the easiest course.

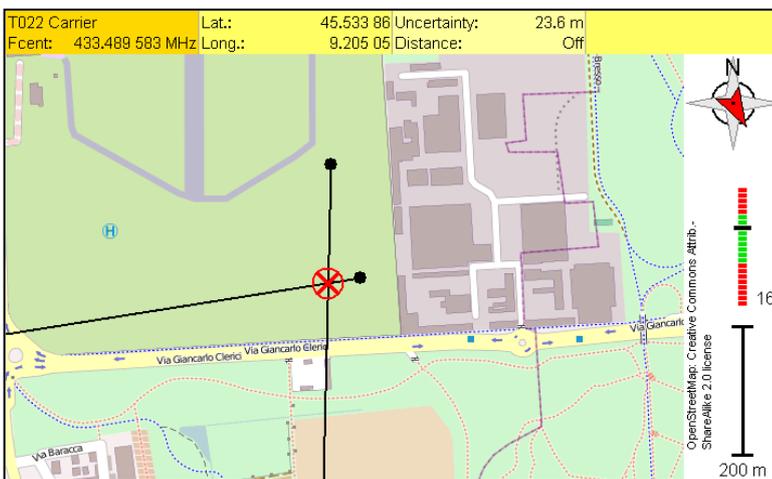
**Figure 6: Taking cross bearings on the emitter on channel T022 locates the source of interference.**

Therefore, we only need to concentrate on the two emitters on channels T022 and T023 rather than trying to localize the interferer at around 432,96 MHz. Using Horizontal Scan and taking cross bearings quickly locates the two emitters (figure 6). Both belong to different emergency services that have set up their transmitting equipment close to each other without any coordination. Apparently, mutual coupling occurs in both transmission paths, leading to the intermodulation products as a result of non-linearities.

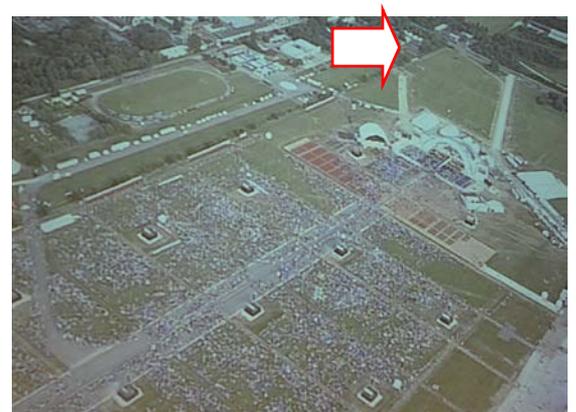
**Figure 7: Emitter location on an aerial photograph of the site transmitted to the security services**
